RE: Kasaan Clinic Site Visit

I am submitting this letter as my field investigation report for a site visit on the proposed Kasaan Clinic property conducted on October 18, 2010. The purpose of my visit was to look at the property and assess whether or not wetlands potentially under the jurisdiction of the U.S. Army Corps of Engineers occur. Please feel free to submit this letter with your information to the U.S. Army Corps of Engineers as you seek their clearance for the proposed project.

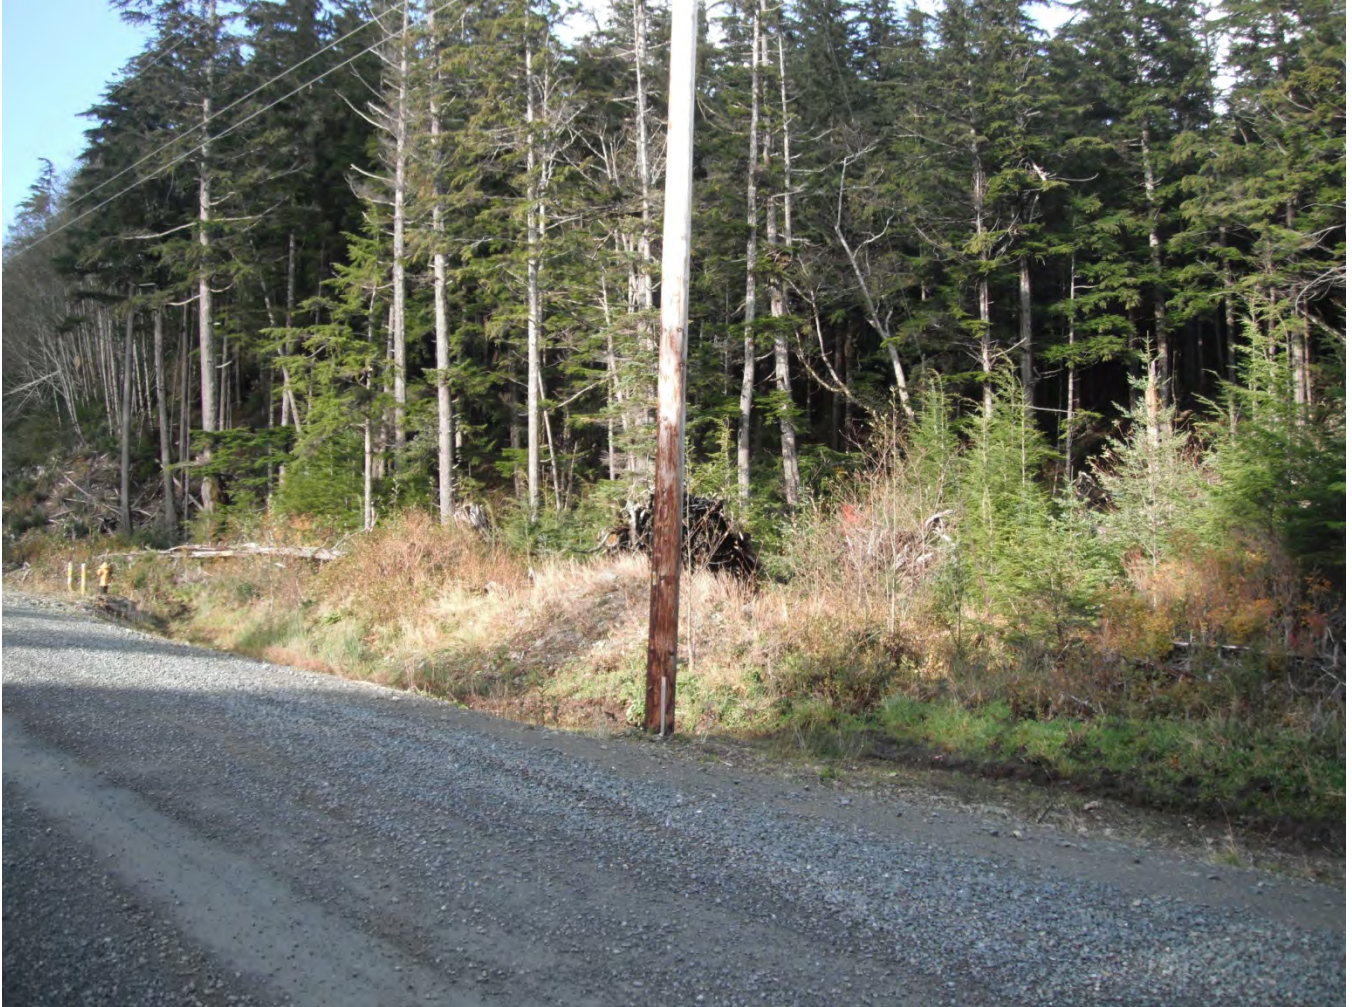
Photo 1. Subject property for the proposed Kasaan Clinic, Kasaan, AK. Picture is taken from the Kasaan-Goose Creek road and shows existing impacts to the property, including electrical utility, fire hydrant, and land clearing with remaining slash.

The total lot size is approximately 0.69 acres, and includes road right-of-way for the Kasaan-Goose Creek road. There are power poles and a fire hydrant located within the road right-of-way. Some vegetation clearing has occurred on the property, and timber slash still remains onsite. While the property is largely undeveloped, these impacts were observed during the field investigation. Photo 1 shows the subject property from the road.

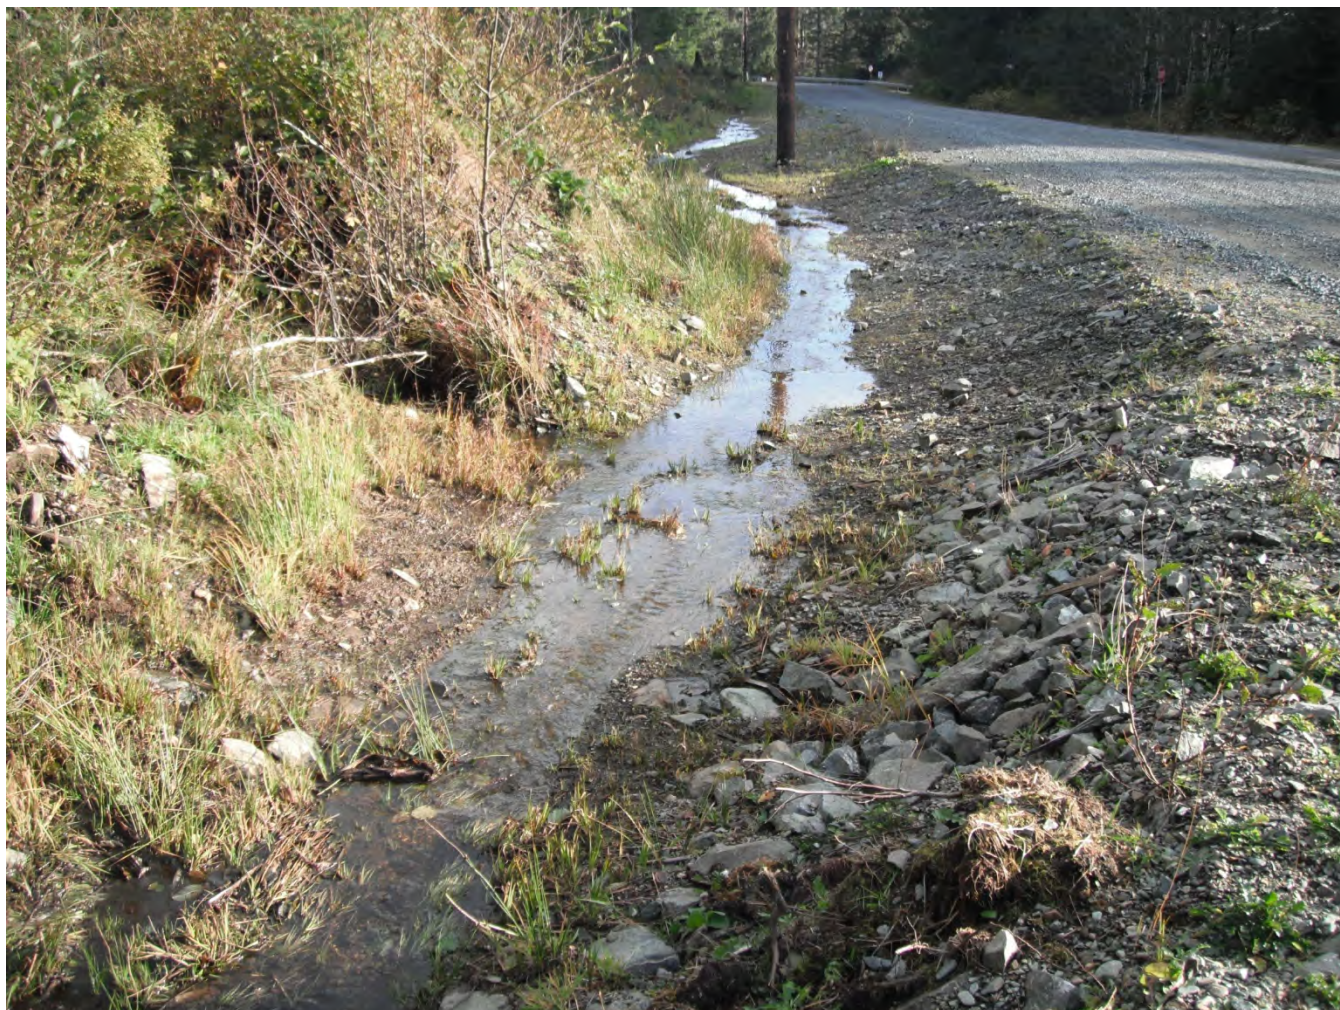
Photo 2: Ditch along the front side of the proposed Kasaan Clinic property, Kasaan, AK. Photo taken from the Kasaan-Goose Creek road.

There are three distinct landforms on the property. On the front side of the property closest to the road there was running water in a ditch along the roadway (Photo 2). Moving into the property, the site is low-lying, flat and has been cleared of trees. There is slash present, with shrub and herbaceous vegetation present. Standing water was observed throughout the lower lying area, and appears to be slowly draining with the gradient of the property towards the ditch alongside the Kasaan-Goose Creek Road. Heavy rains preceded this site visit, so it is unknown if standing water remains for long periods of time. The property gives rise to steeper slopes that still have intact hemlock/spruce over-story, with little to no understory. Figures 1 and 2 show the contours for the site, and Photo 3 depicts a broad overview of all three site descriptions.

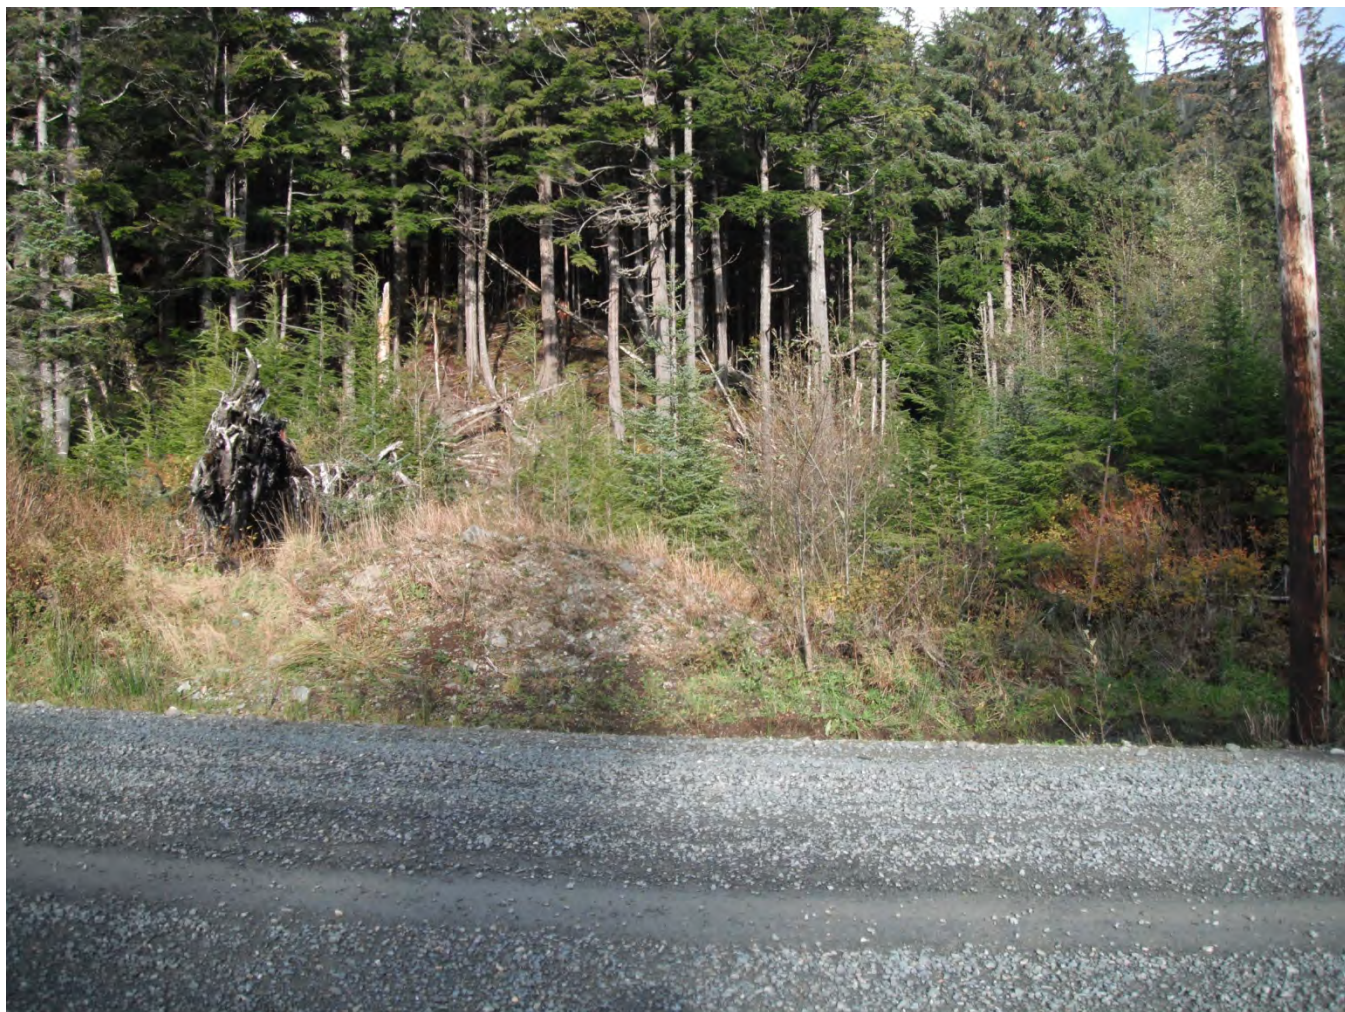
Photo 3. Proposed Kasaan Clinic site, showing cleared flat area and slopes with intact over-story vegetation.

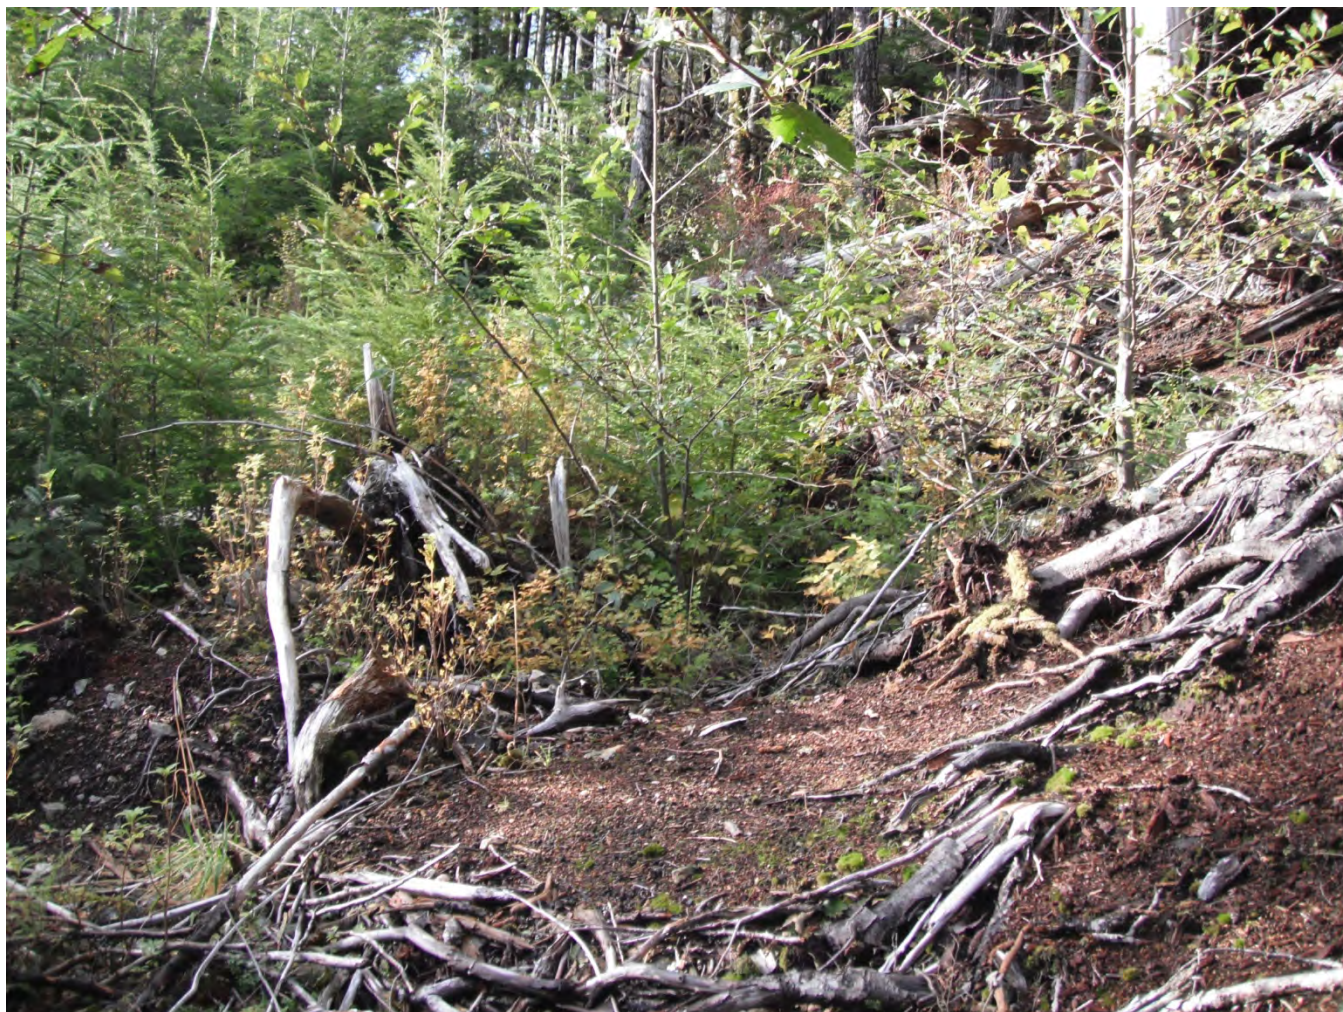
Photo 4. Toe of slope on the proposed Kasaan Clinic property, Kasaan, Alaska. The right side of the picture shows roots of large living hemlock trees with little to no ground vegetation, while the left side of the pictures shows tree sapling and some herbaceous vegetation.

Because the site visit was outside of the growing season, no formal wetland data according to U.S. Army Corps protocol was taken. In addition, there was no formal delineation between probable wetlands and uplands on site. In general, it appears that wetlands may be present and extend from the front side of the property to the toe of slope. Figure 2 depicts the approximate boundary where wetlands transition into uplands, based on visual observations of vegetation and topography. If the transition between wetlands and uplands proves to be the toe of slope, then there are approximately 0.26 acres of wetlands on the subject property (as depicted in Figure 2). Photo 4 shows site conditions at the toe of slope, and Photos 5 and 6 show representative vegetation communities for the lower lying flat area on site.

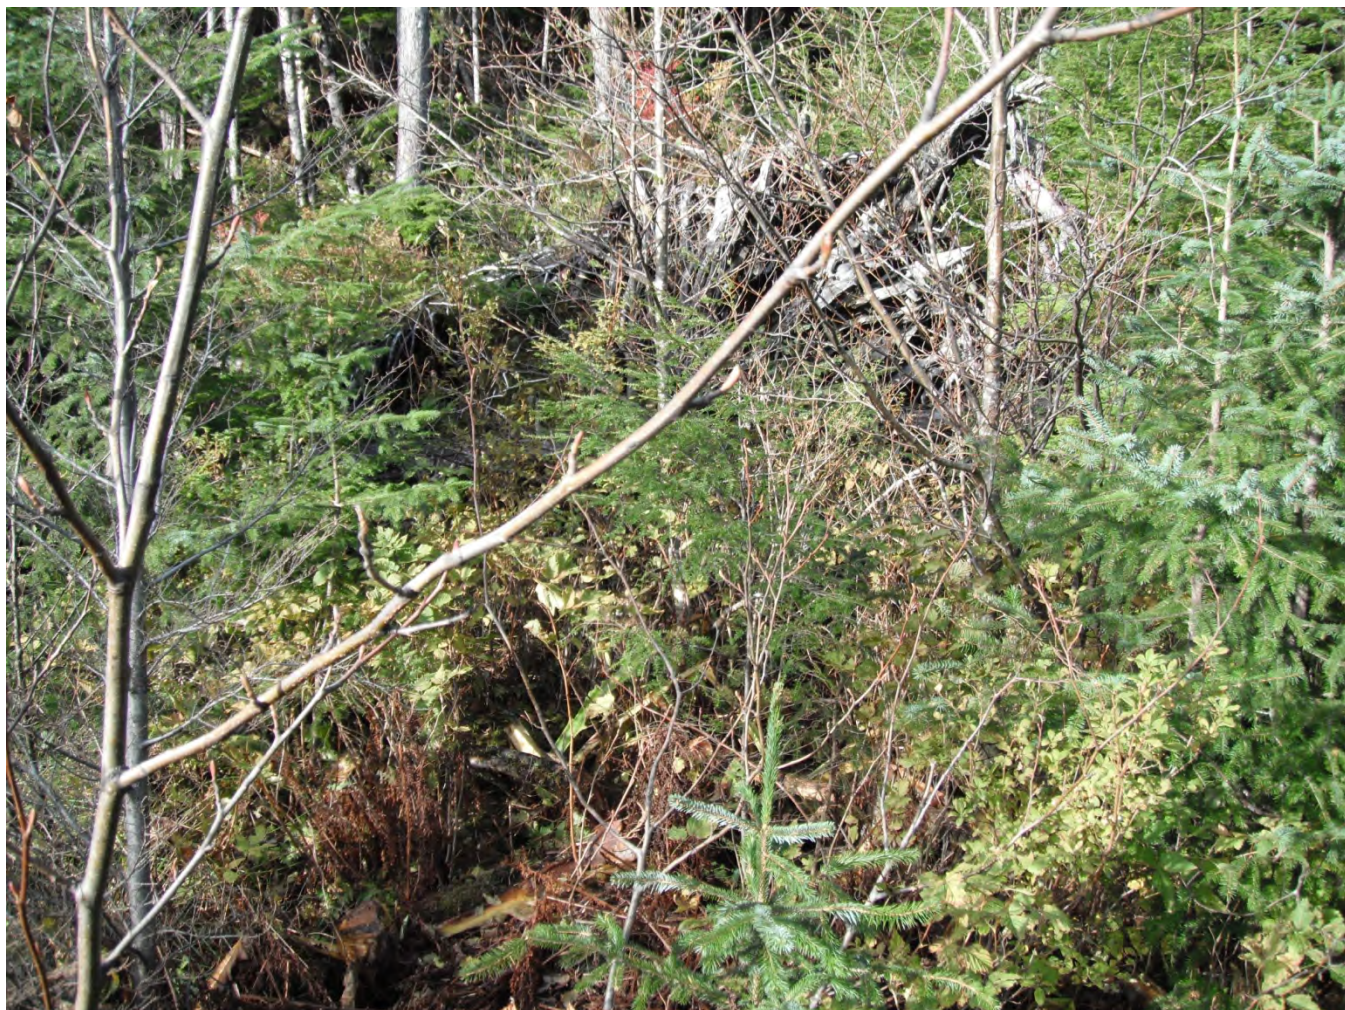
Photo 5. Vegetation present in cleared flat low lying area of the proposed Kasaan Clinic Property, Kasaan, AK. Vegetation is dominated by spruce/hemlock saplings, alder saplings, *Vaccinium spp*, and *Rubus sp*.

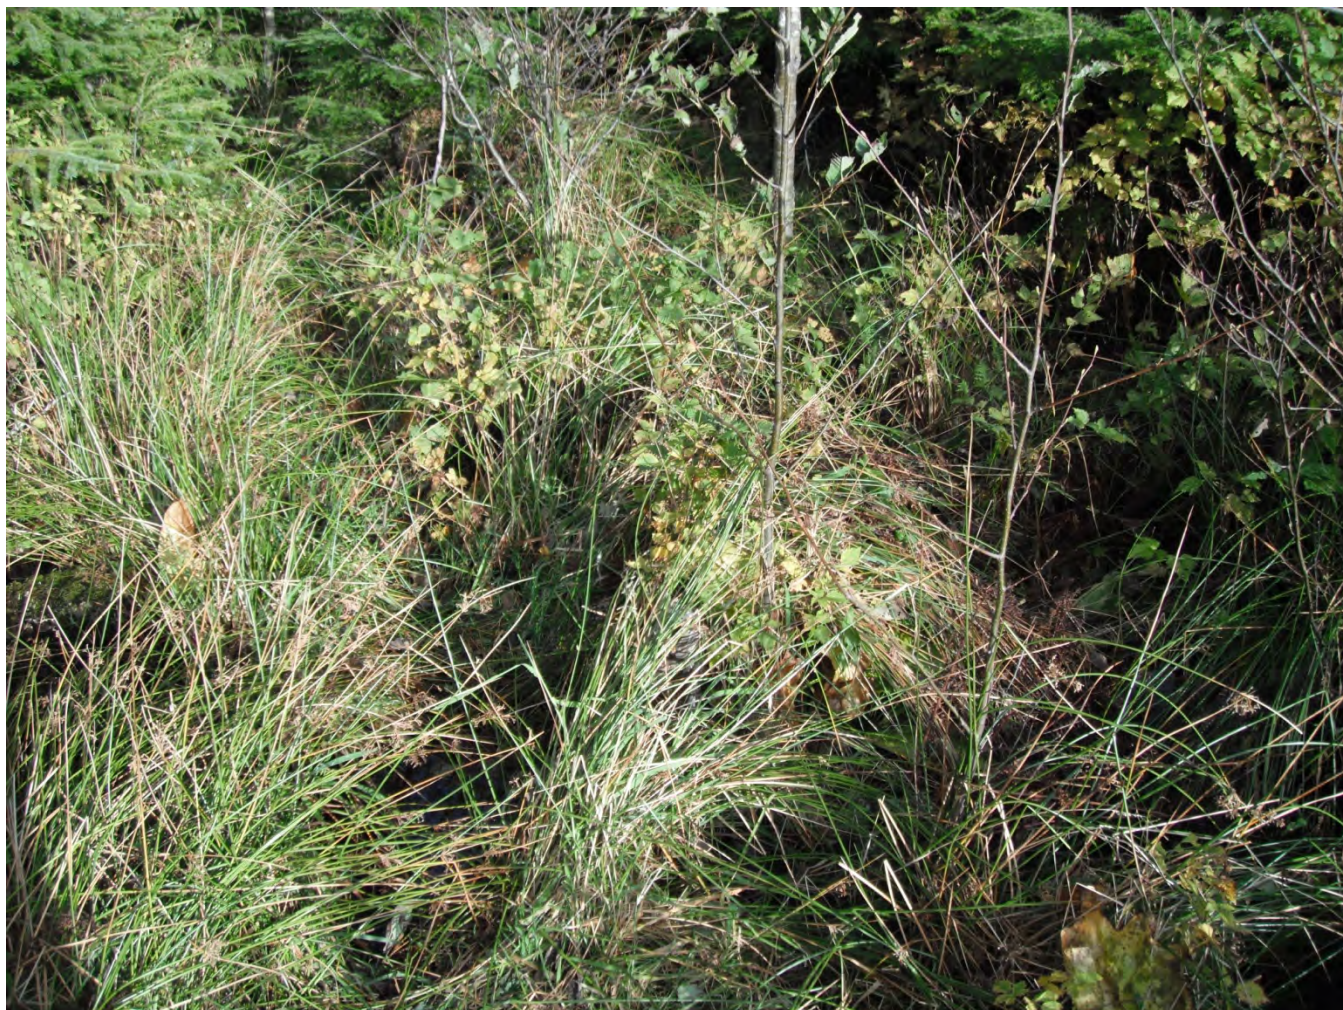
Photo 6. Wetland vegetation observed on proposed Kasaan Clinic Property, Kasaan, AK. In addition to *Rubus sp.*, there were areas of *Juncus sp.* and *Lysochiton sp.* growing in standing water.
